EFFECTS OF THE ATOMIC BOMB ON NAGASAKI,
JAPAN

Physical Damage Division

JUNE 1947

13 October-20 November 1945

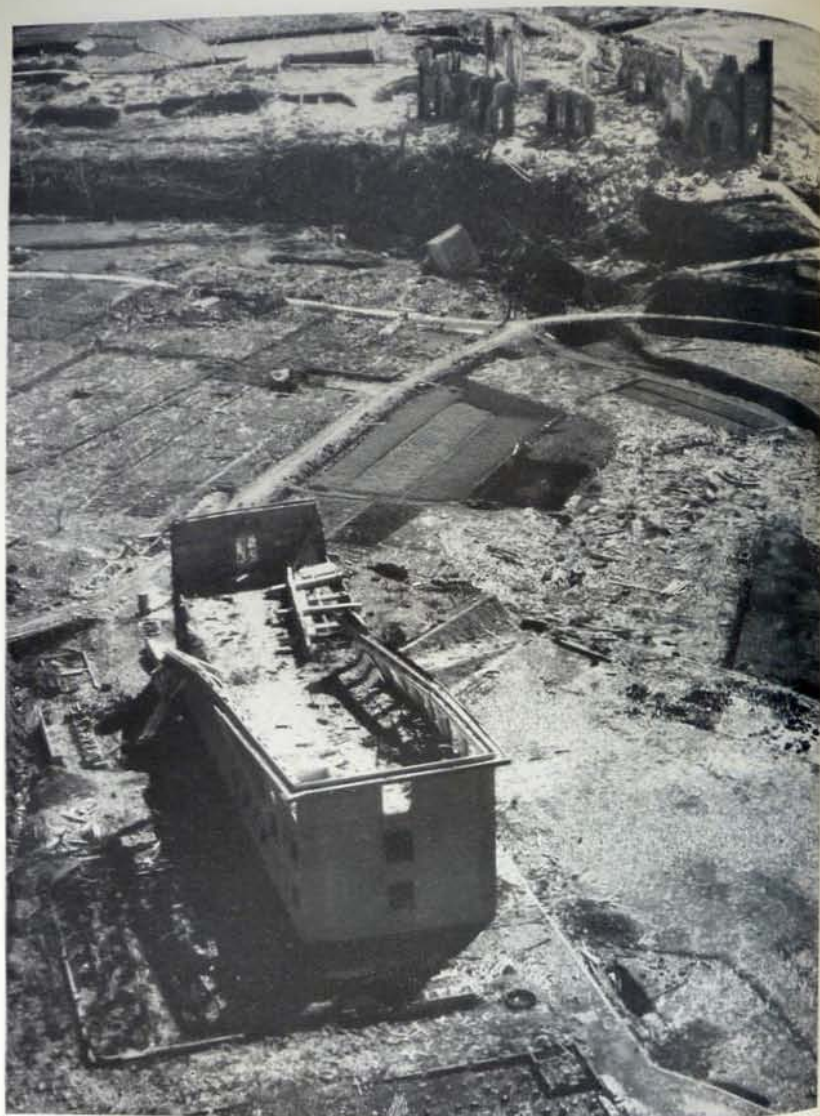
Photo 56.—1,900 feet from GZ. Group 14, Building 1, aerial view looking southeast showing roof burned away and destroyed concrete walls. Urakami Cathedral (Group 15) at upper right corner.

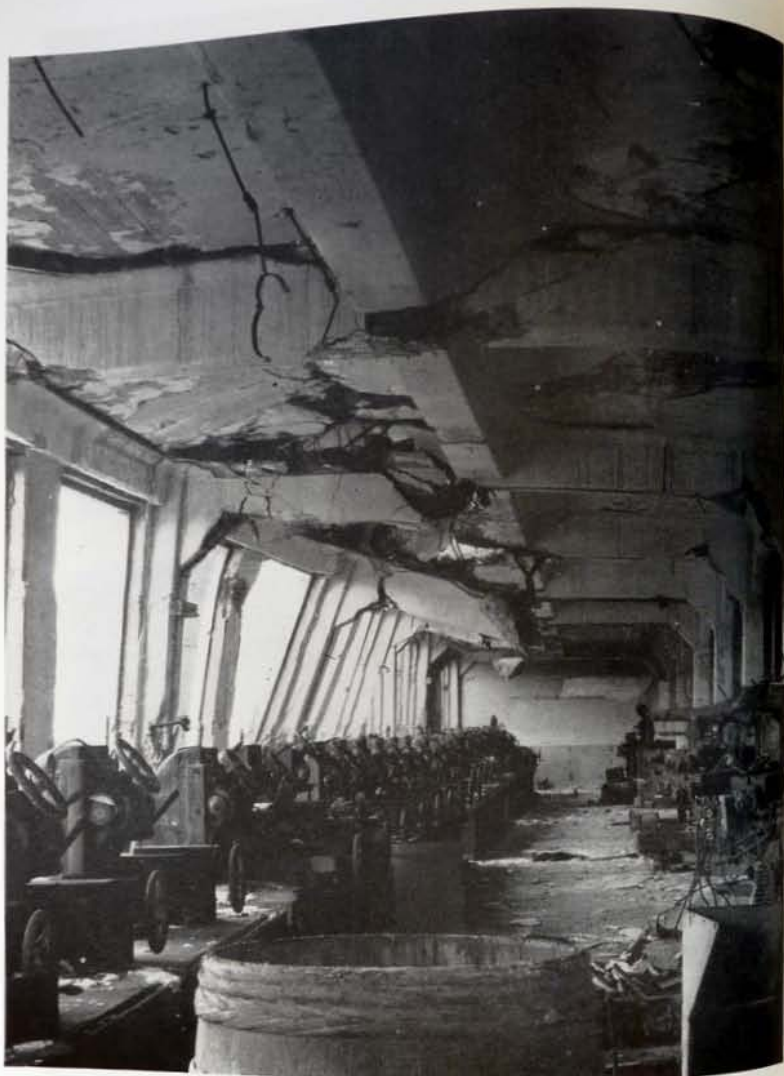
Photo 67.—1,900 feet from GZ. Group 14, Building 1, looking west on second floor showing failure of columns at window sill height and beams at intermediate longitudinal beam point. Note third-floor slab buckled upward.

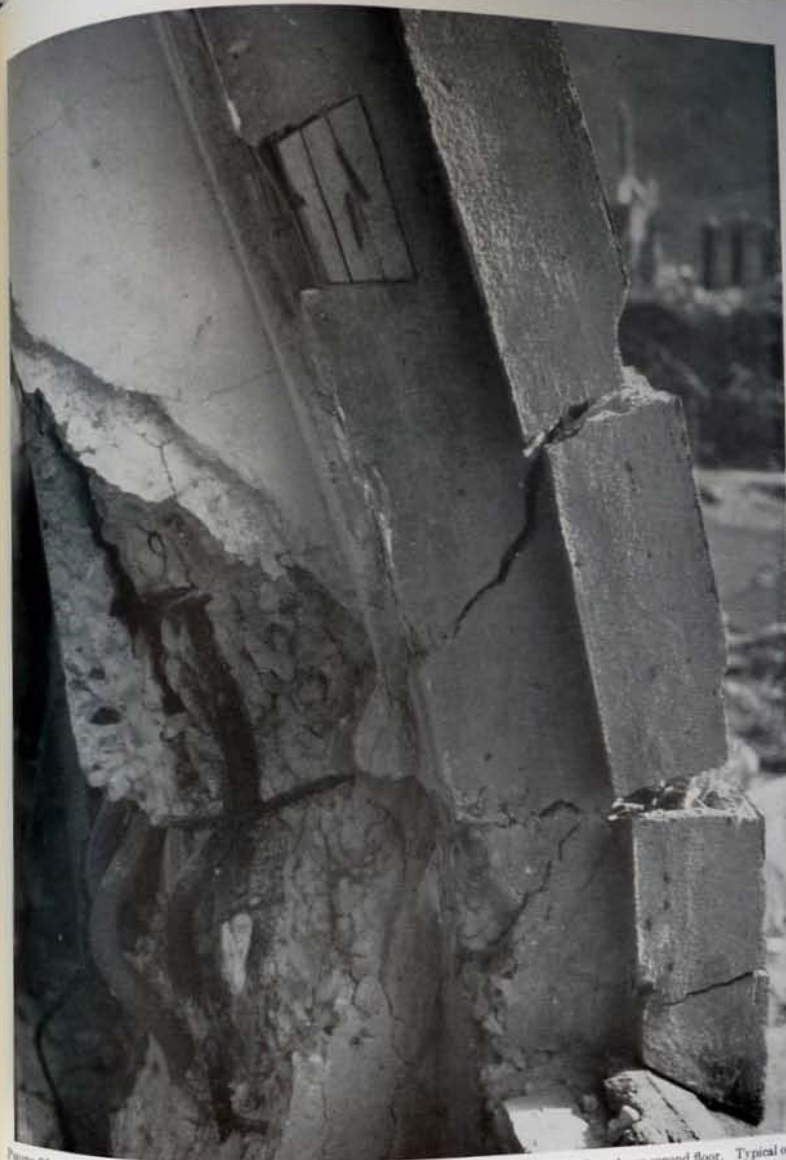
Photo 68.—1,900 feet from GZ. Group 14, Building 1, Column 6A cracked at point 3 feet above second floor. Typical of failure in column rows A.

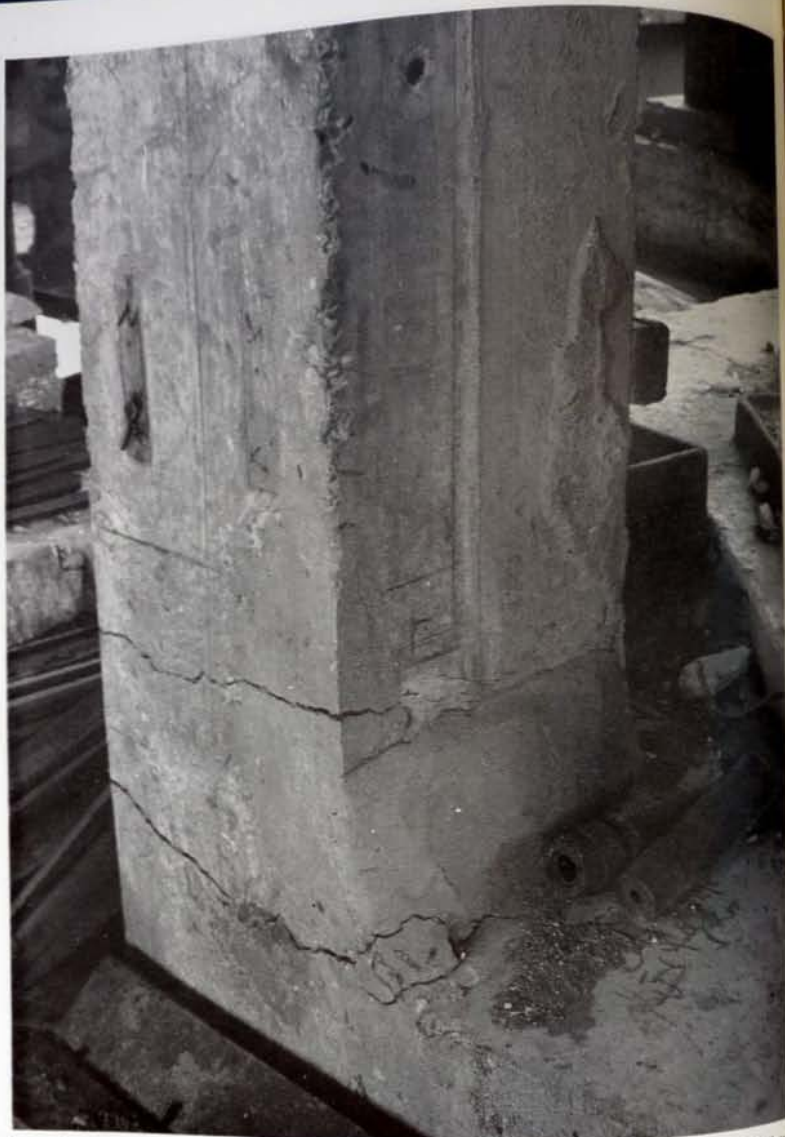
Photo 69.—Group 14, Building 1, cracks on south side of Column 6C. Typical of failure at base of all interior columns.

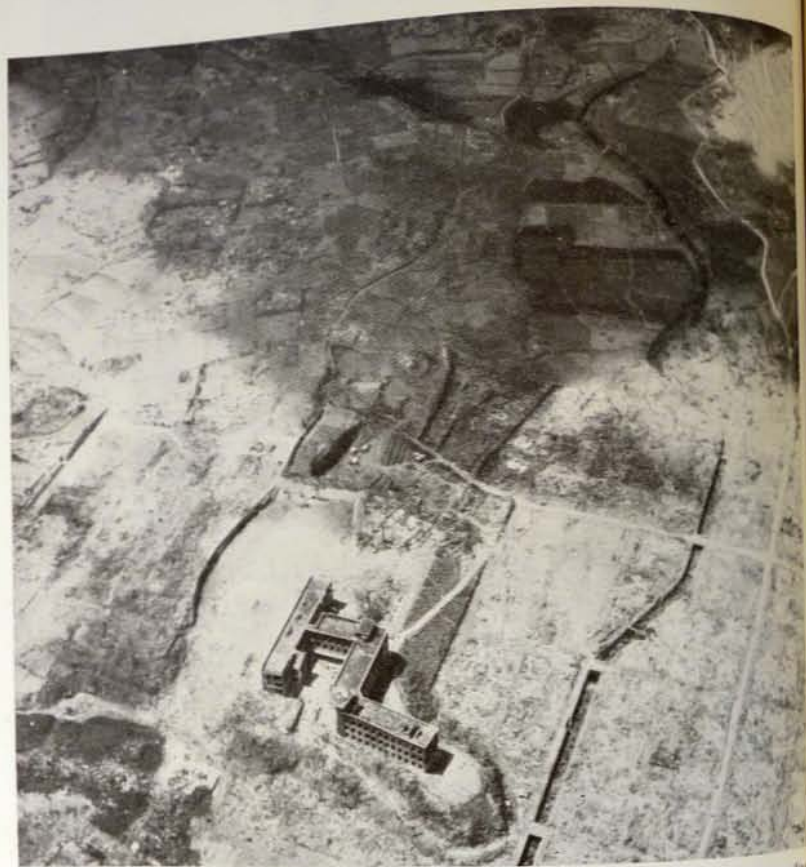
PHOTO 84.—1,600 feet from GZ. Group 16 photo taken 3 September 1945 showing east end of Building 2 still standing. The end of this building collapsed at a later date.

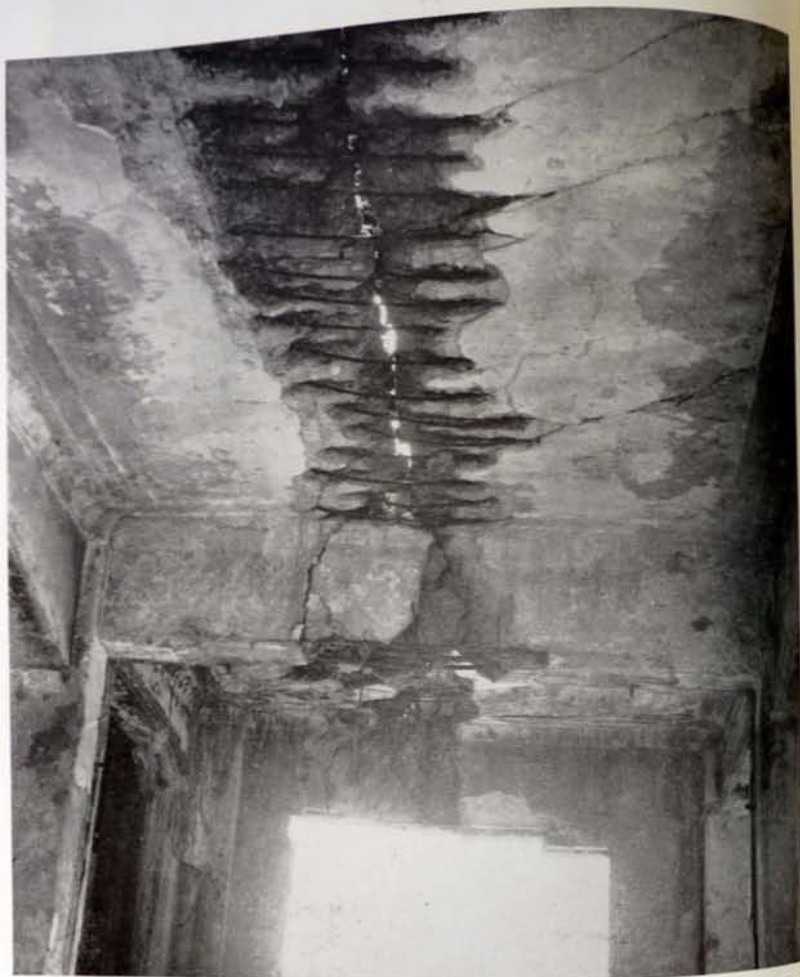
Photo 96.—Group 16, Building 1, looking up and west at concrete slab and beam of third floor in east wing. Section of slab north of crack thrust west $2\frac{1}{2}$ inches between column rows 20 and 21.

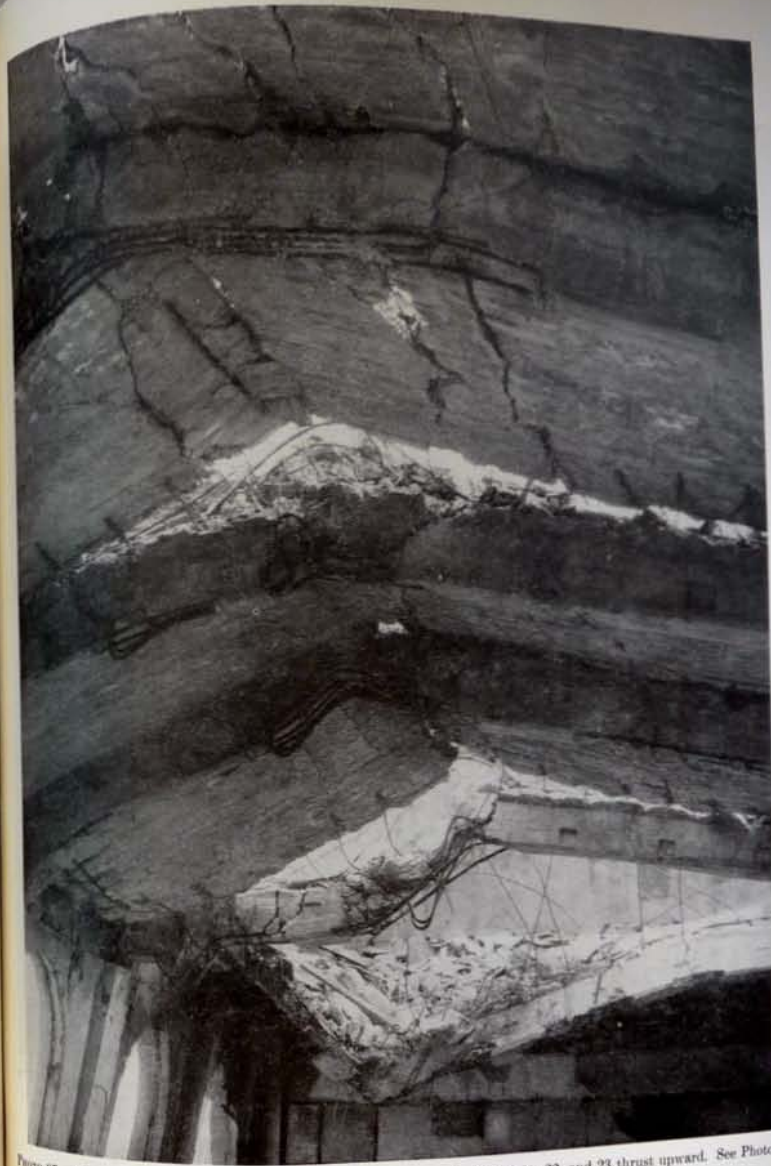
Photo 97.—Group 16, Building 1, roof Beam 20 thrust downward, Beams 21, 22, and 23 thrust upward. See Photo 88.

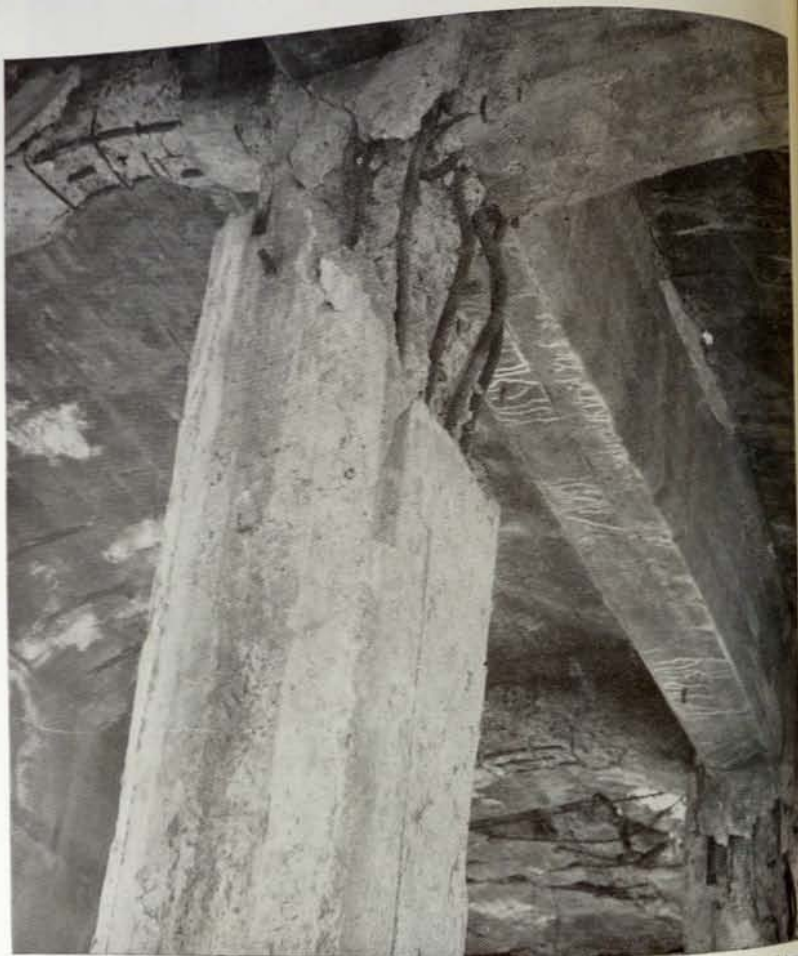
Photo 98.—Group 16, Building 1, looking up and south at typical columns failure at roof slab in west wing, Column 4B shown.

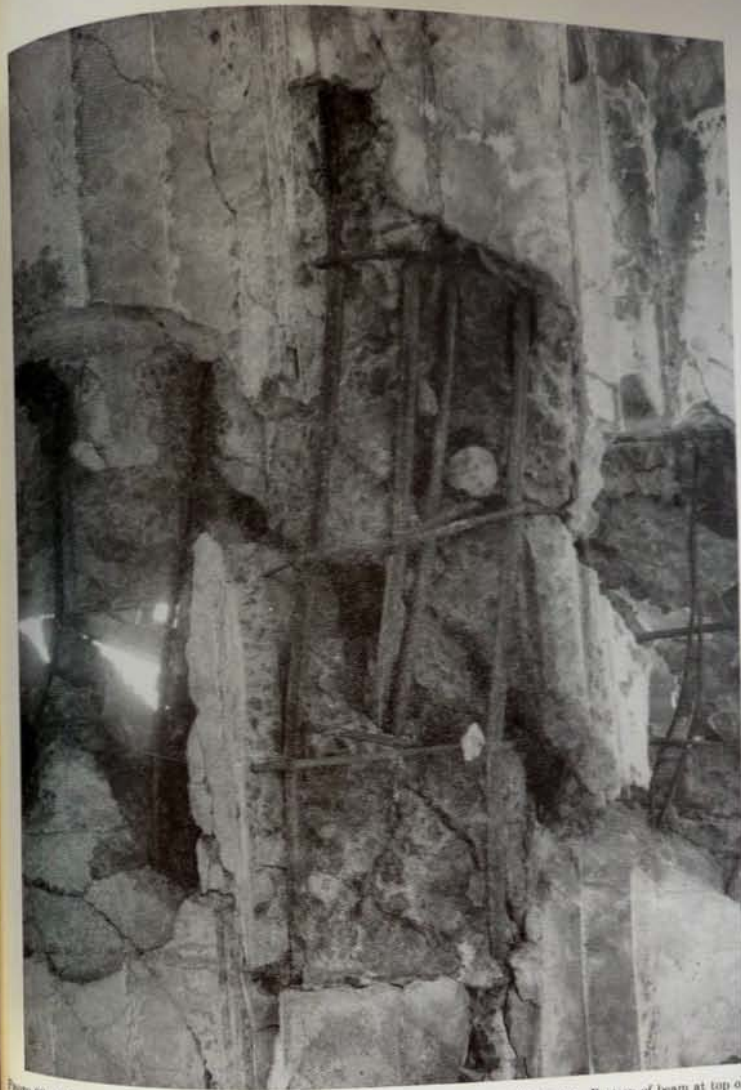
Photo 99.—Group 16, Building 1, looking directly up at Beam B, shown in Photo 96. Portion of beam at top of photo thrust west between column rows 20 and 21.

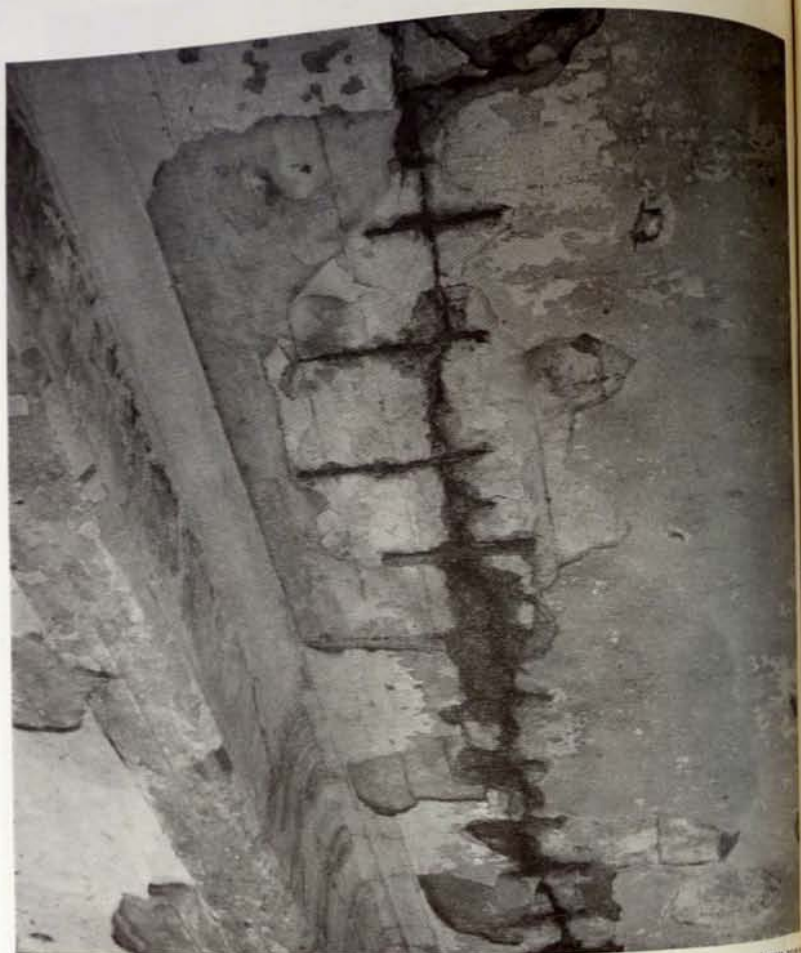
PHOTO 100.—Group 16, Building 1, looking up and east at crack in second floor slab in east wing between columns nos. 26 and 27. Section of slab north of crack thrust west $1\frac{1}{2}$ inches.

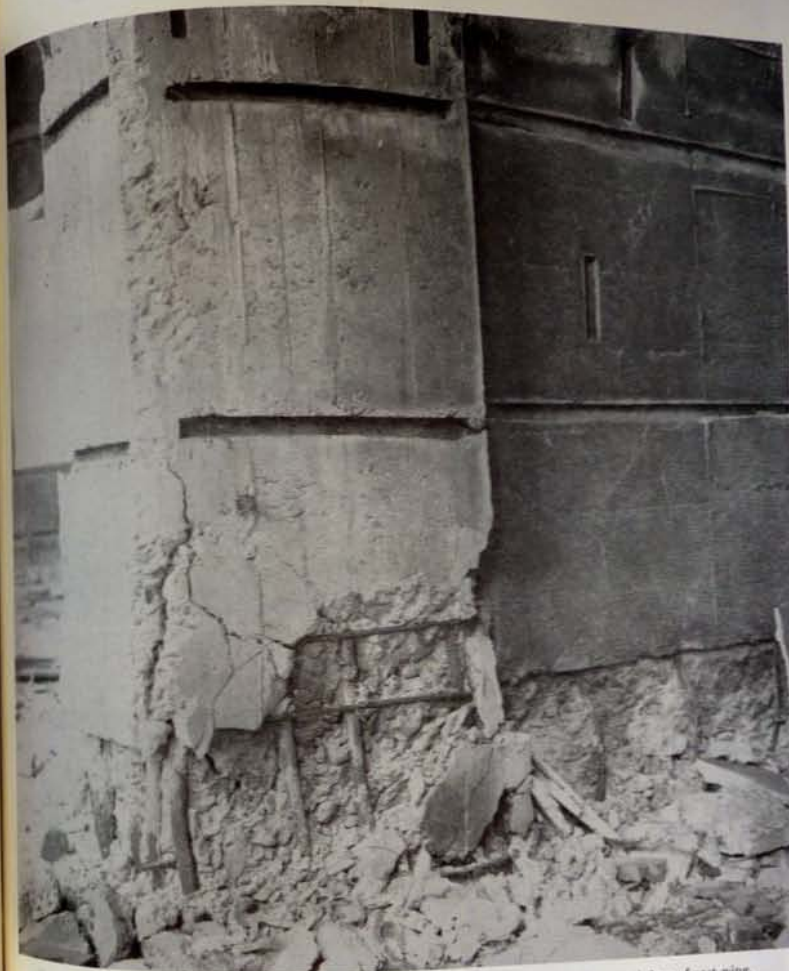
PHOTO 101.—Group 16, Building 1, looking northeast at base of Column 19B, second floor of east wing.

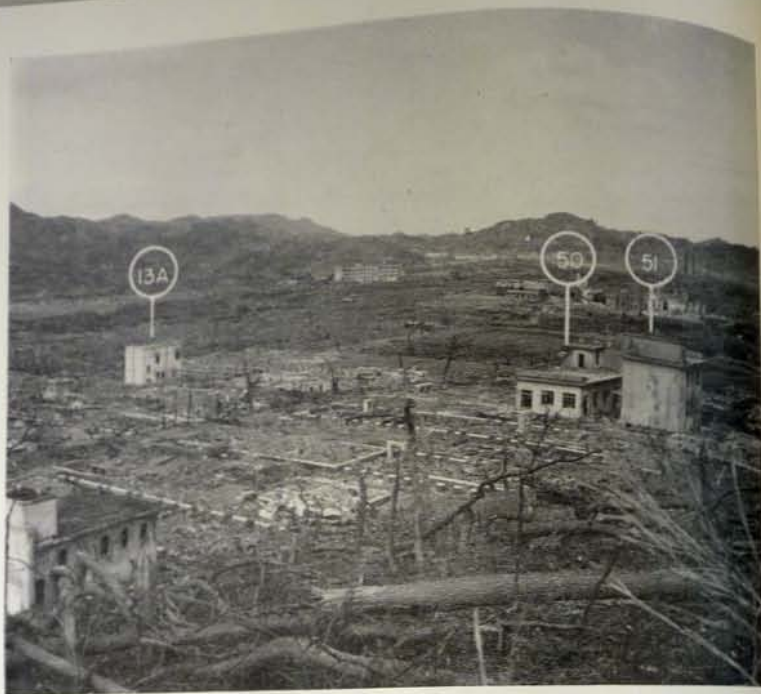
Photo 121.—1,500 feet from GZ. Group 17, general view looking northwest over debris of burned buildings.

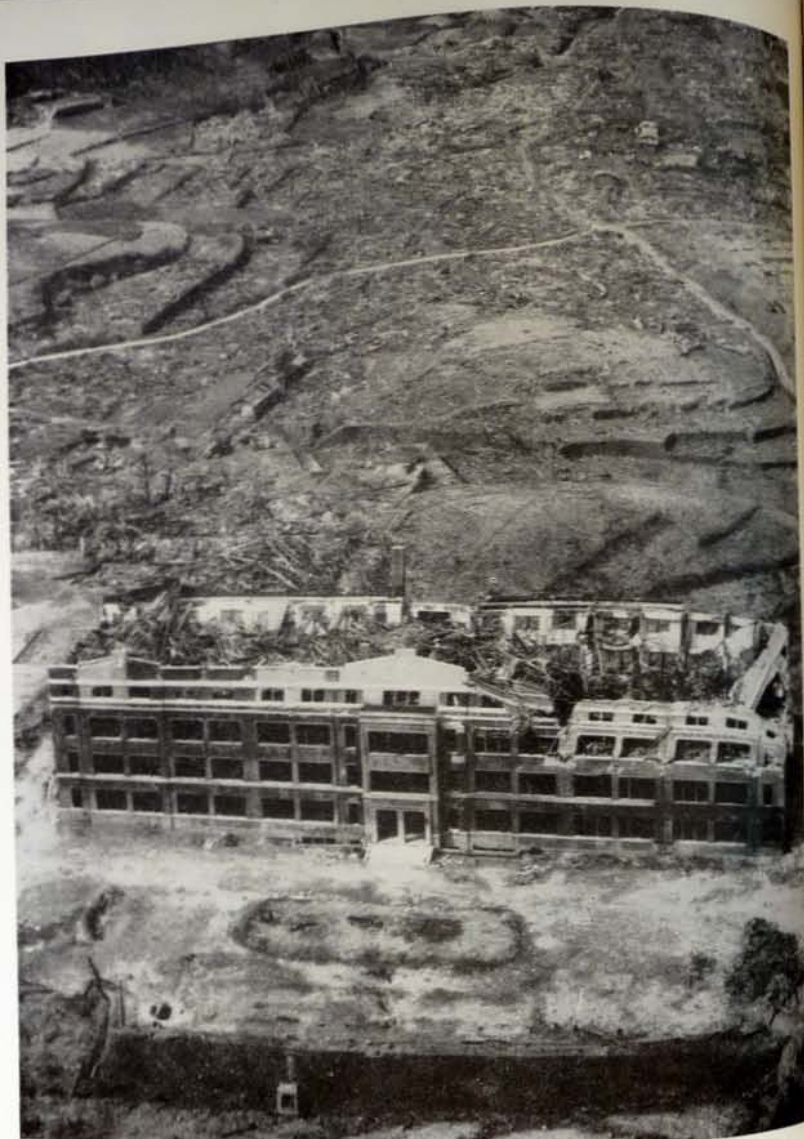
Photo 127.—1,500 feet from GZ. Group 18, Building 1. Aerial view looking west at Chinzei School.

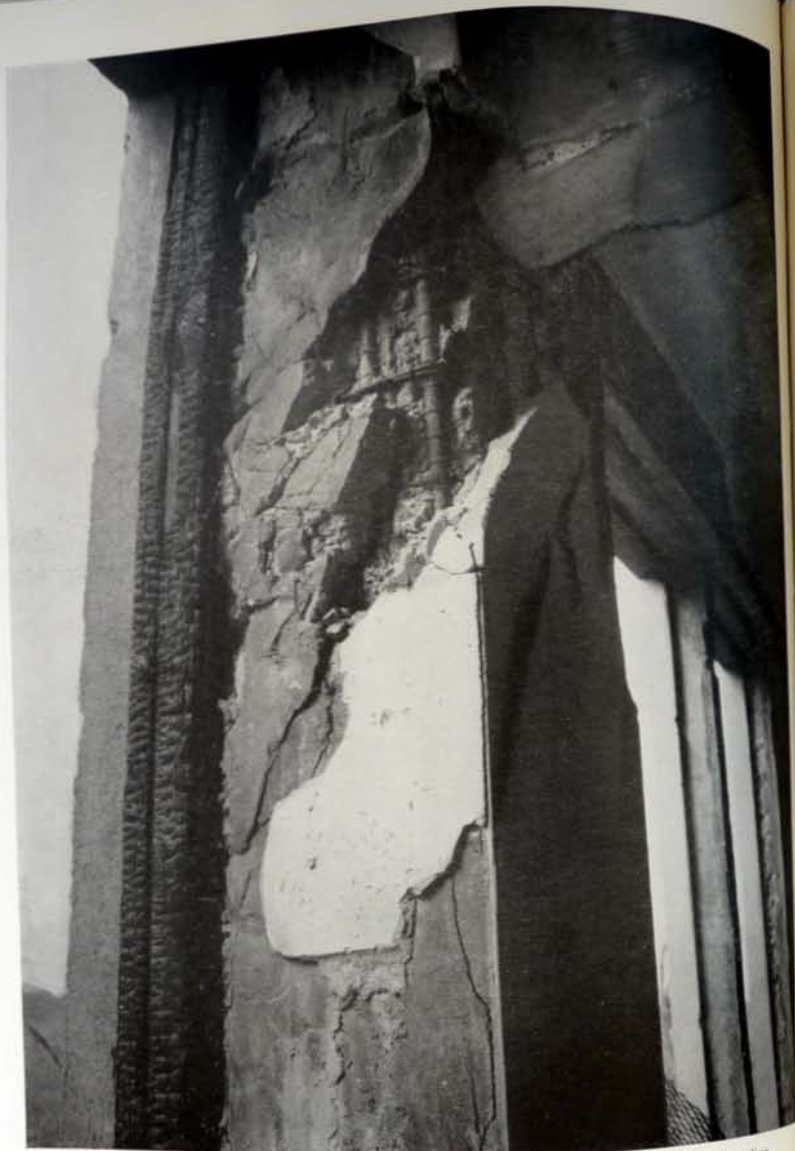
Photo 145.—1,500 feet from GZ. Group 18, Building 1, damage to column 4D below second floor line.

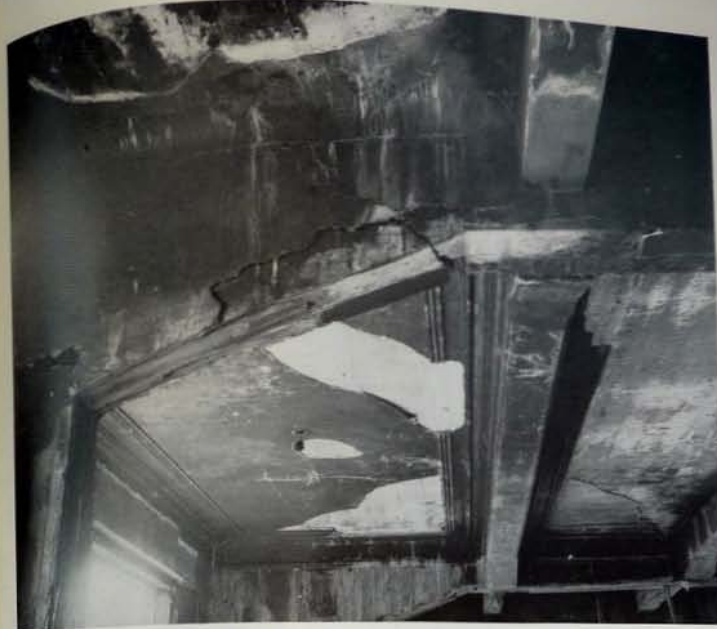
Photo 154.—1,500 feet from GZ. Group 18, Building 1, east end of Beam 9 supporting second floor cracks typical of failure in beams throughout building.

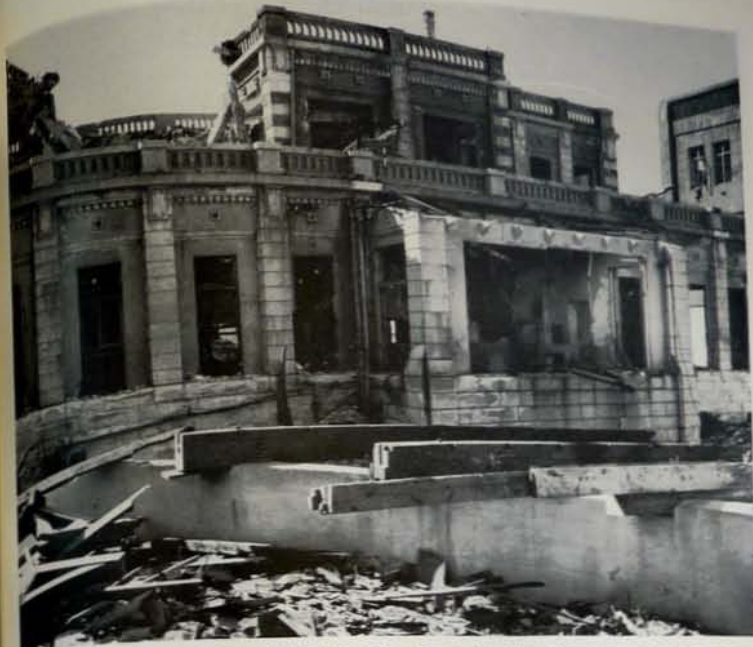
Puoro 158.—2,200 feet from GZ. Group 20, Building 17, north wall of building. Damage to roof and two-story section caused by high-explosive bomb prior to 9 August 1945.

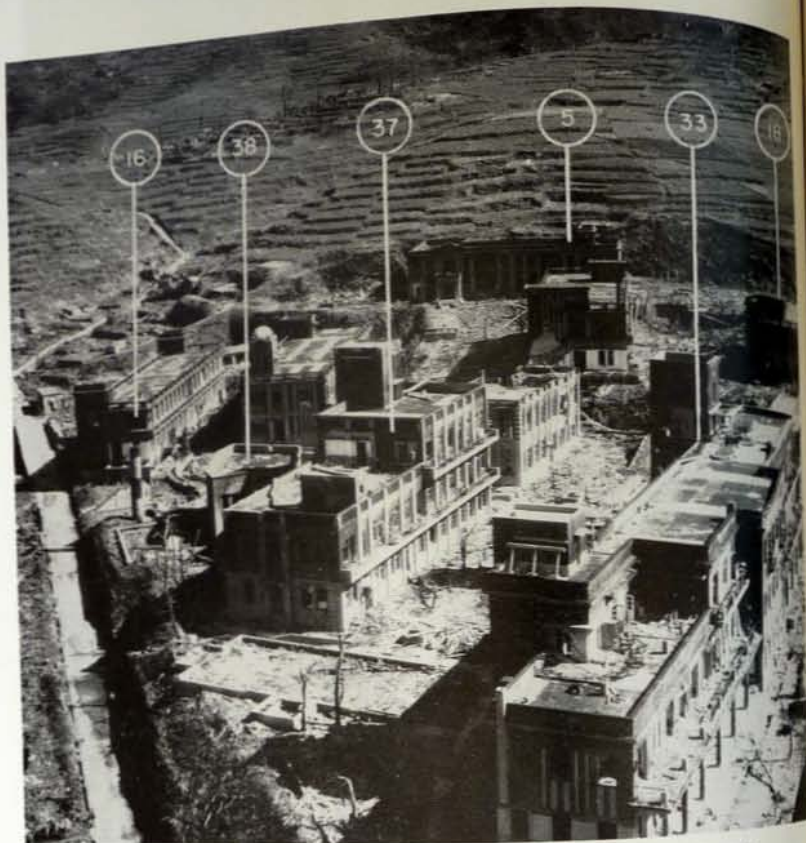
Photo 170.—2,200 feet from GZ. Group 20, aerial low oblique looking east, Building 33 at lower right corner.

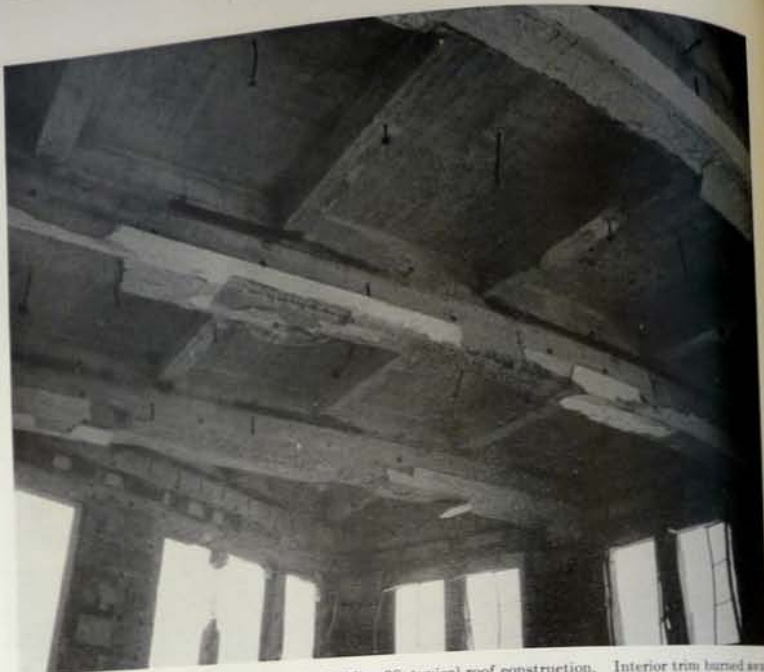
Photo 180.—1,800 feet from GZ. Group 20, Building 38, typical roof construction. Interior trim burned away.

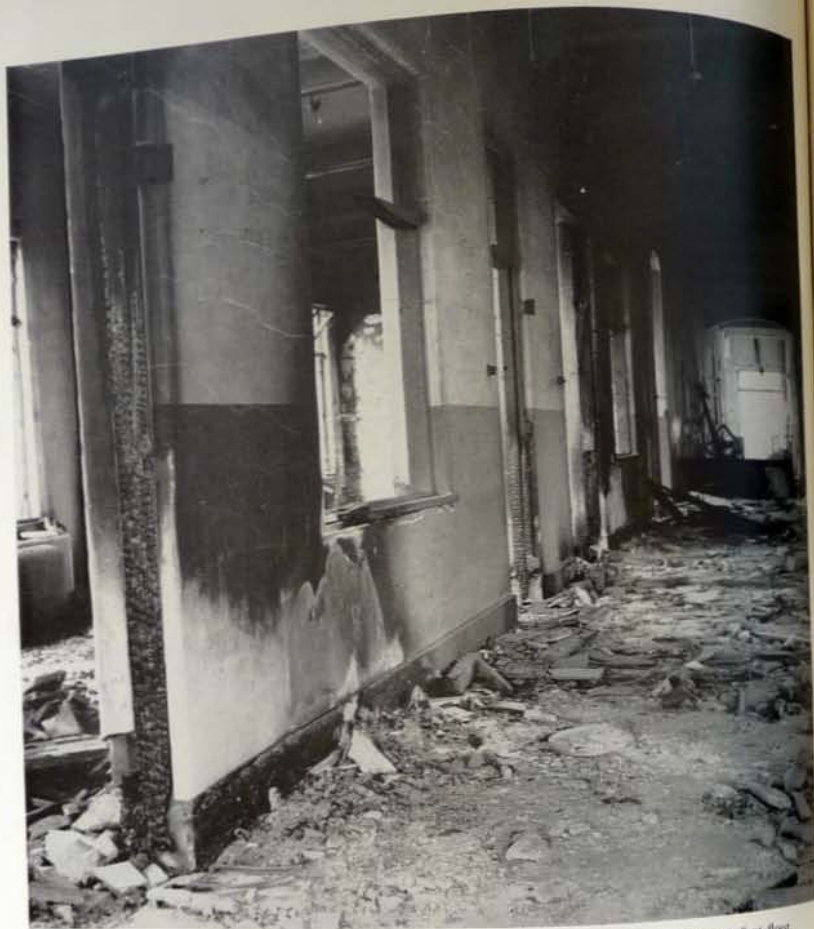
Photo 186.—2,100 feet from GZ. Group 20, Building 32, interior view showing fire damage on first floor.

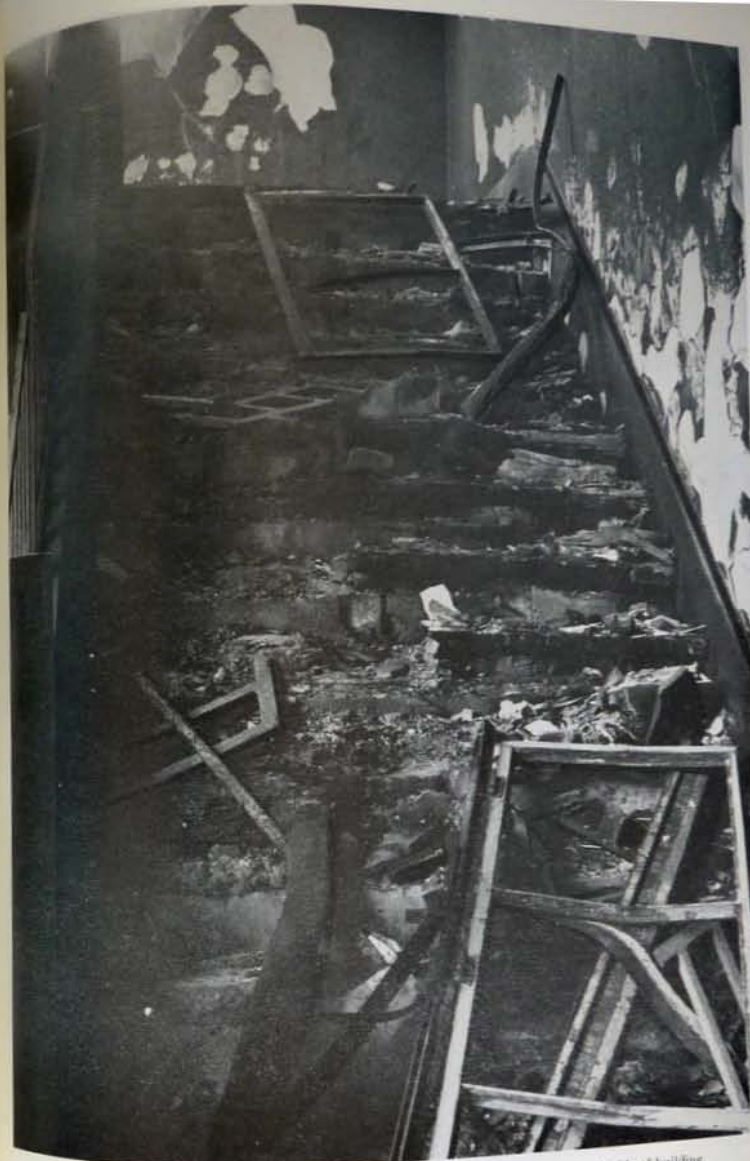
PHOTO 199.—2,100 feet from GZ. Group 20, Building 32, burned stair at north side of building.

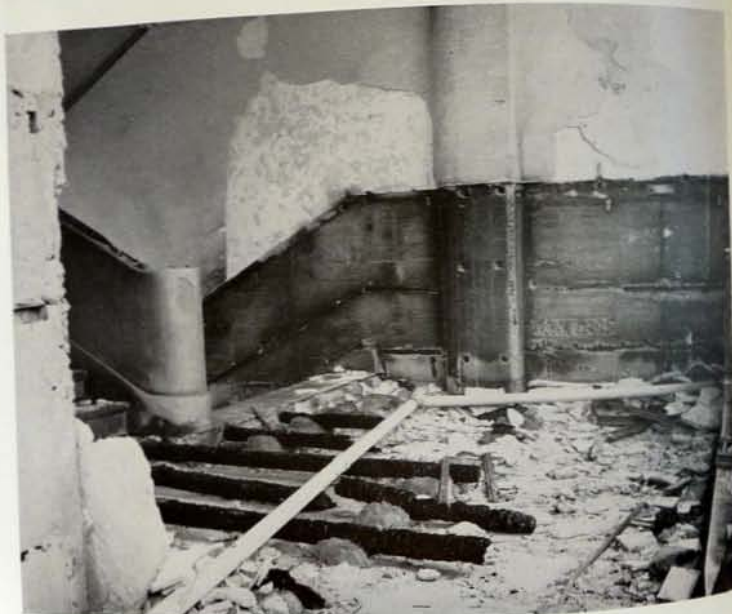
PHOTO 213.—Group 27, Building 1, fire damage in stair and corridor.

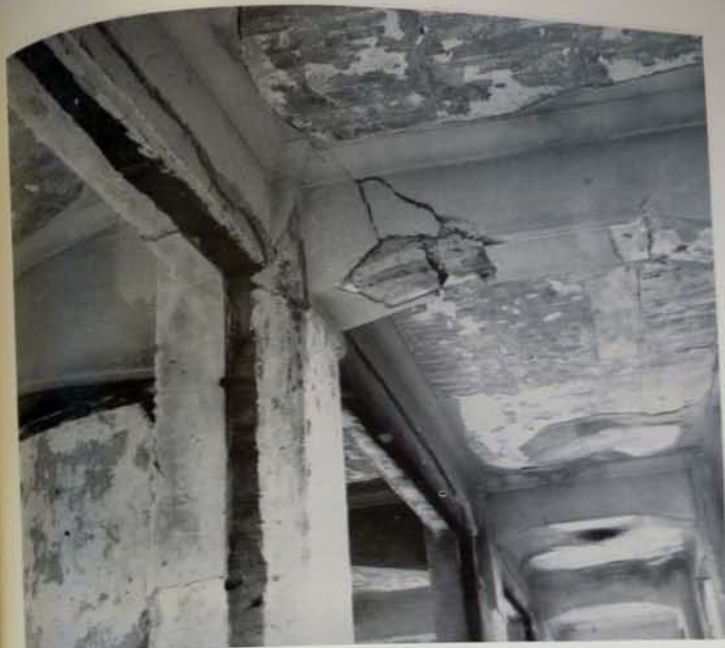
PHOTO 214.—3,700 feet from GZ. Group 27, Building 1, typical beam failure on third floor.

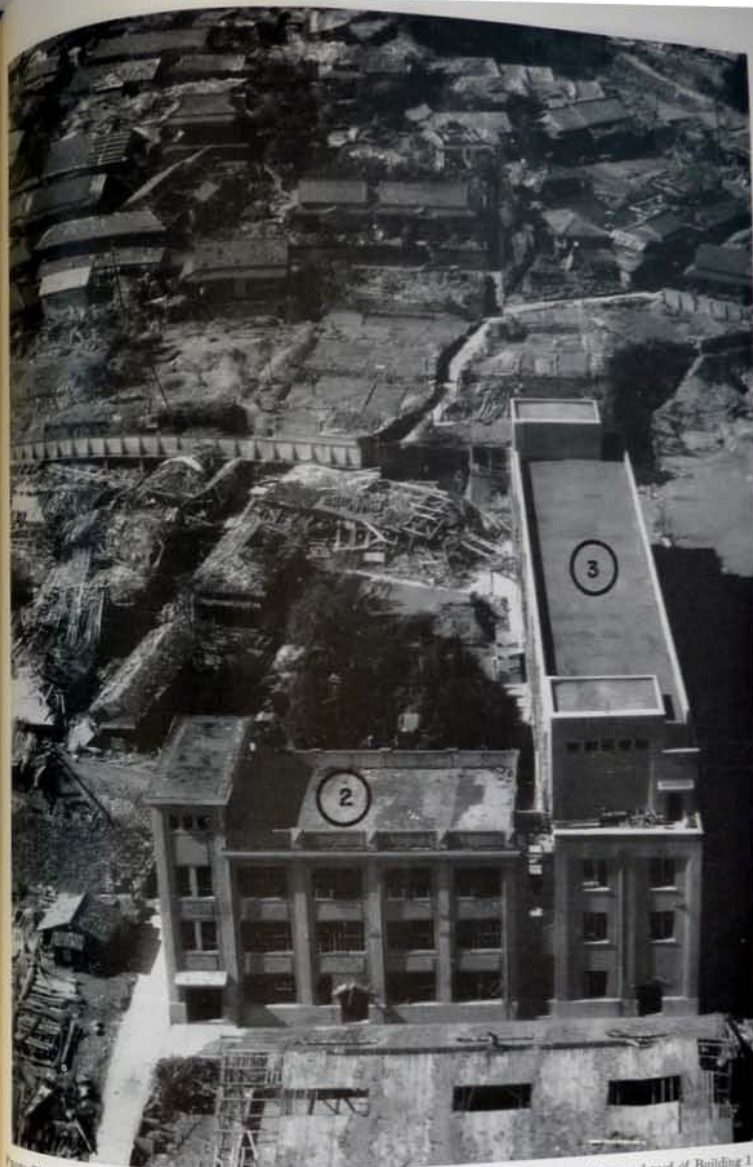
Photo 230.—6,300 feet from GZ. Group 38, aerial view looking west at Inasa School. Damaged roof of Building 1 at bottom of photo.

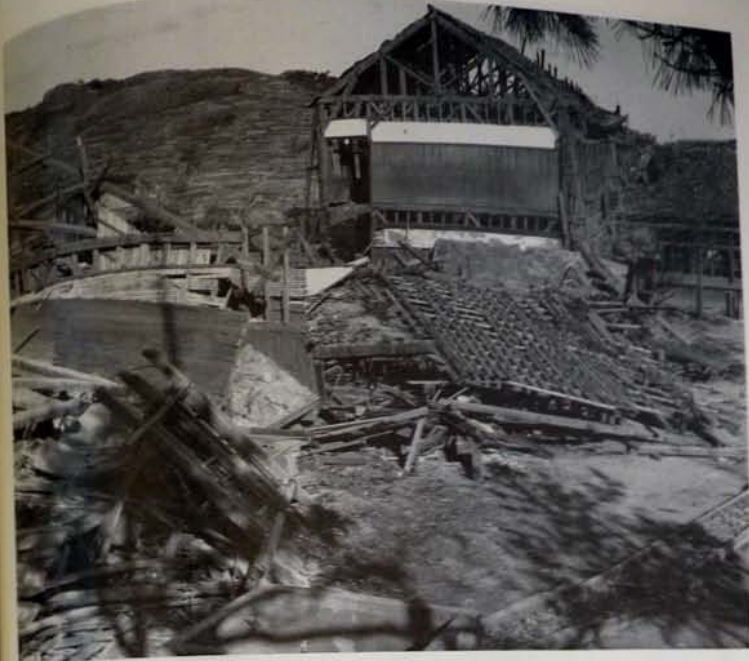
Photo 238.—8,300 feet from GZ. Group 48, Building 2, Asahi School, looking northeast at blast damage to typical one-story Japanese school building.

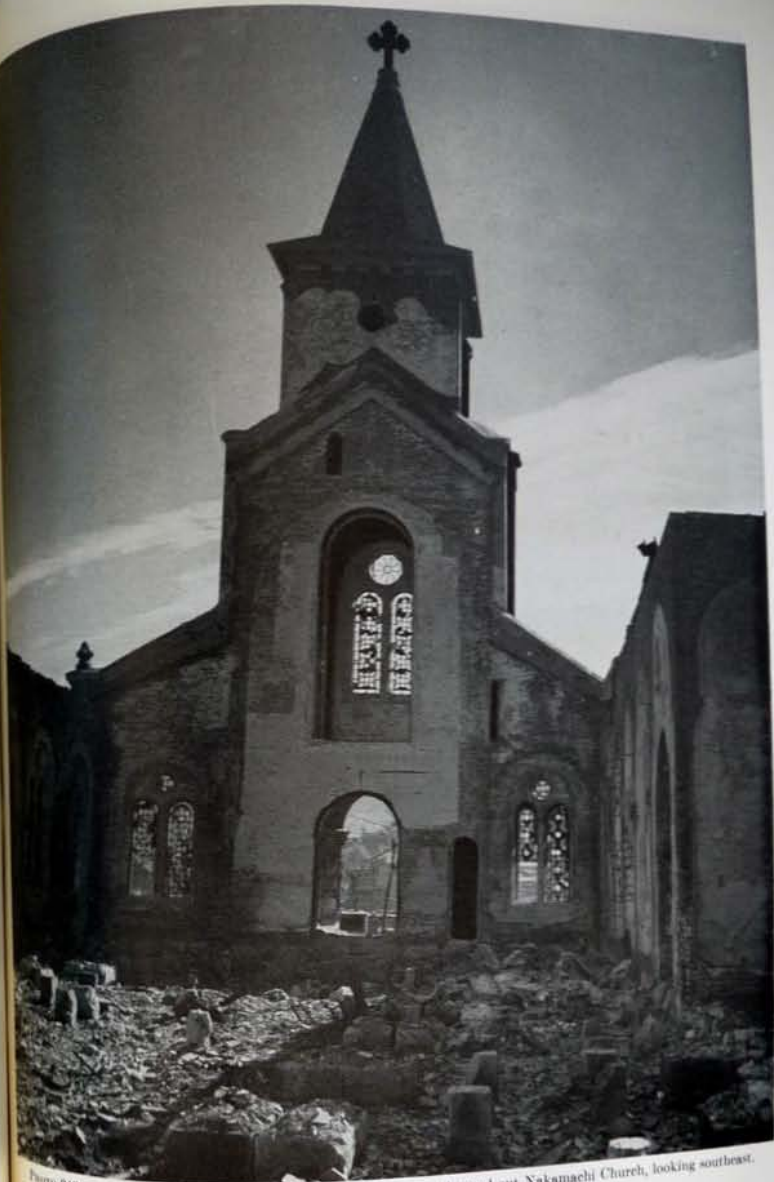
Photo 243.—8,800 feet from GZ. Group 70, interior view of burned-out Nakamaehi Church, looking southeast.

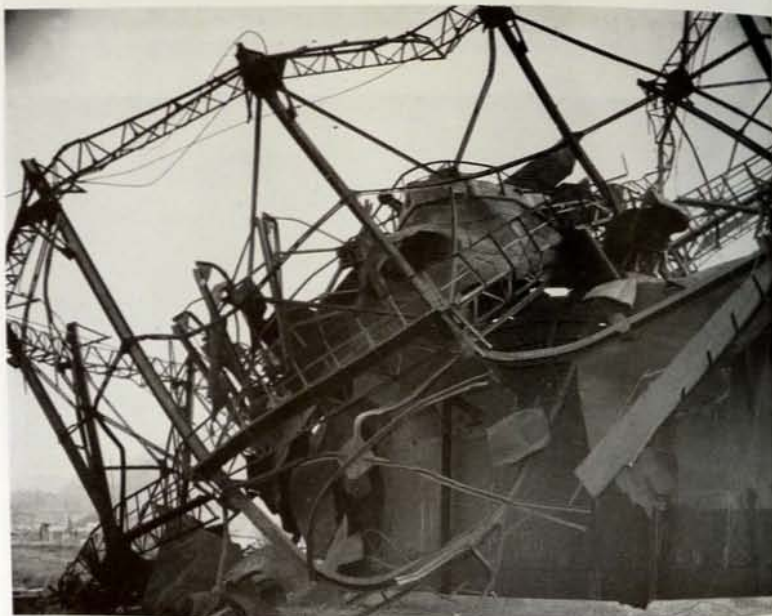
PHOTO 58.—3,000 feet from GZ. Damaged tank top of gas holder, Ohashi Gas Works.

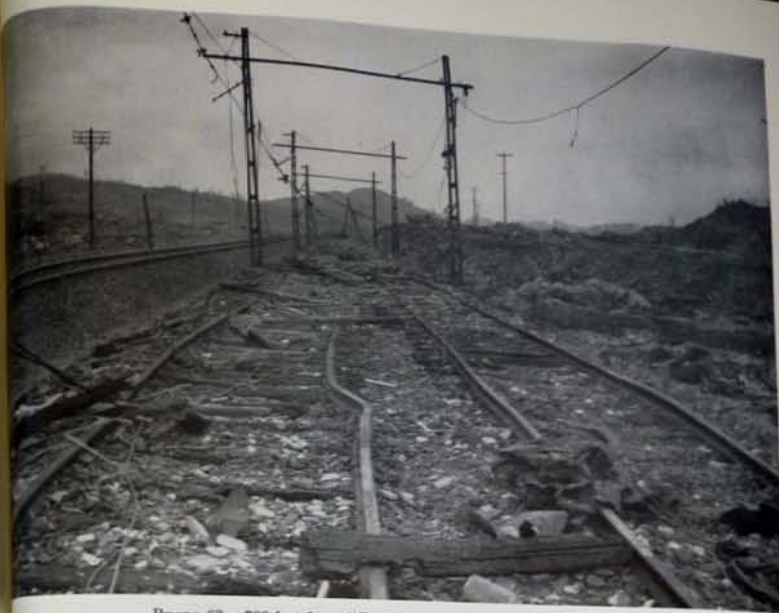
PHOTO 63.—300 feet from GZ. Section of track damaged by fire.
